**EXISTING FACILITIES
EVALUATION REPORT**

Project: Episcopal Church of the
Resurrection
Greenwood, South Carolina

Re: Electrical Systems Evaluation

A/E Project Number: 10-C1070

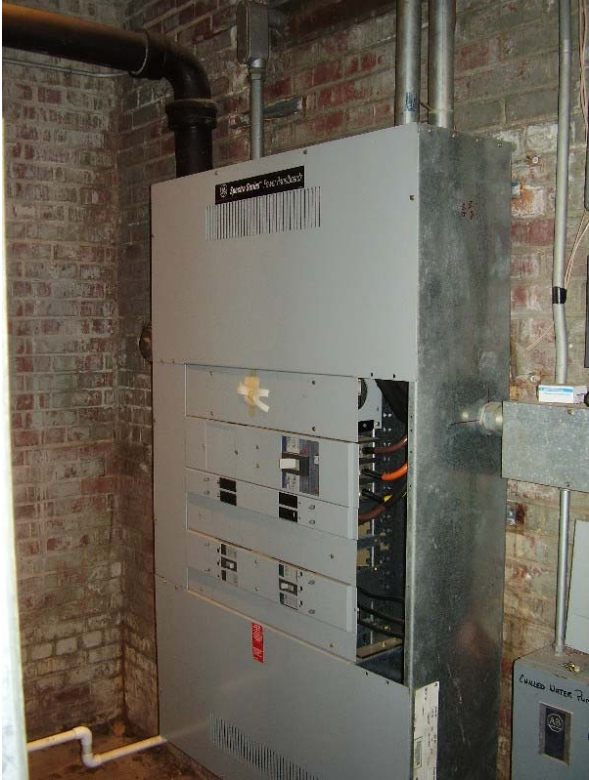
2. There is no main circuit breaker. In order to disconnect power to these buildings, all four breakers must be switched off. The NEC does allow up to six individual grouped disconnects, but this is not considered a desirable design. Also, the breakers are not marked "Service Disconnect" as required by code, which could be a source of confusion for a fire fighter or someone servicing the building.

4. Color coding of the conductors do not meet industry standard practice in some cases. For example, brown tape on the service conductors would normally indicate a 277/480 volt system.

Sanctuary main panel. Note lack of main circuit breaker and non-standard color coding of conductors. Although the "high leg" is required to be orange, the brown, orange, yellow combination is commonly used for 277 / 480 volt systems.

1. Label the main panel breakers "Service Disconnect" as required by code. Provide a nameplate designating the panel amps and voltage rating. Provide tag indicating high leg delta service.

4. Correct tape color coding of phase conductors where non-standard colors have been used.
5. If a major building project is undertaken, consider reworking the service to standard 208Y120 volts. Both the sanctuary and Bishop's Hall could possibly be re-fed from the service panel in the new building. This is not a difficult conversion, but any motor operated equipment would need to be checked for correct operation, because it would be working at 208 volts after the change. Many times this is not a problem because most HVAC equipment is dual rated at 208-230 volts. (The chiller is rated 208-230)

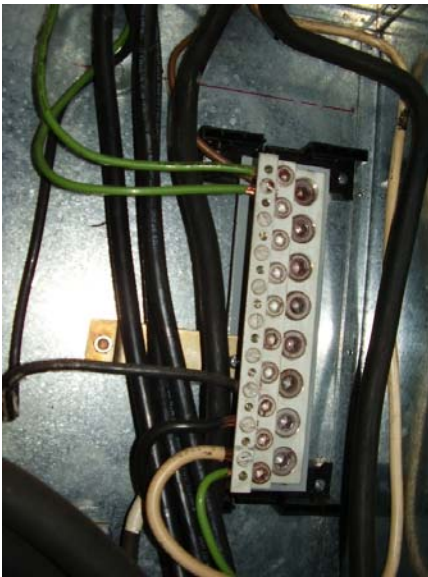
3. There is no ground bar or grounding electrode conductor in the panel. The neutral bar is bonded to the metal panelboard can and both neutral and ground conductors are terminated on it. The NEC requires a grounding electrode for every service, which would consist of driven ground rods, water pipe, if present, and building steel or footing rebar, if present. The only system ground is from the utility neutral connection and incidental contact with metal conduits. There should be separate ground and neutral terminal bars with a single connection from ground to neutral.

Main panel neutral bar used as a grounding point. There should have been a separate ground bar provided in the panel, along with a main grounding conductor as required by code.

2. Provide a service ground electrode as per the NEC. This is a safety issue that must be corrected.
3. Provide a ground bar kit in the main panel and rework to separate the neutral bar.

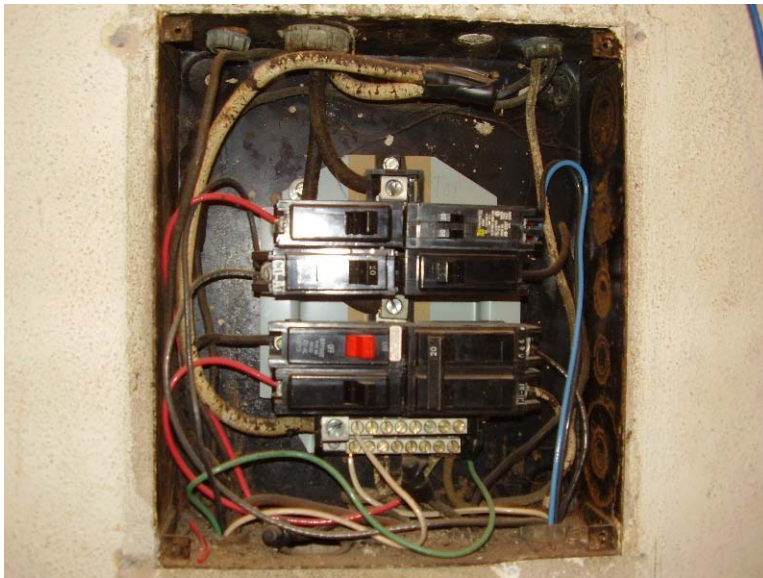
2. The old fabric insulated wiring is well past its service life, which as a rule of thumb is about 40-50 years.
3. The sanctuary panelboard is undersized, in poor condition, contaminated with dirt and debris, and in a location that does not allow proper clearances and working space. The NEC requires a 30" wide by 3 foot deep working space in front of this panelboard to allow safe access and working space.

Sanctuary panelboard with cover removed. Note deteriorated condition and presence of dirt, debris, and old fabric insulated conductors. There are no available spaces or spare breakers left.

7. Consider completely rewiring the sanctuary building, including a new panelboard, new conductors, and new switches and receptacles. Branch circuit grounding conductors would be provided, and receptacles could be added where needed. Existing metallic conduits and wall boxes could be reused in most cases. The Federal Pacific panel should be relocated and replaced, or eliminated if Parrish house is ever demolished.

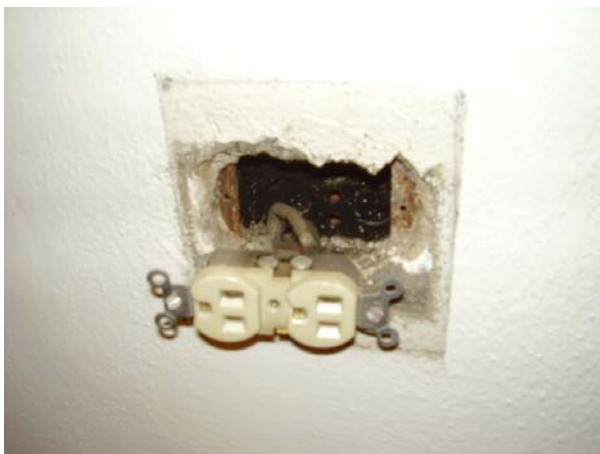
6. Some of the old two wire receptacles have been replaced with new three wire type with ground prong, but there is no ground conductor present, nor was there a connection to the metallic box. This is a code violation. Use of an appliance or tool with a grounding type cord would not be properly grounded and could produce a shock hazard.

Convenience receptacle at the front of the sanctuary near the choir area. Note old fabric insulated conductors and lack of a grounding conductor. This is a 3 wire grounding type receptacle, but is not properly grounded as installed.

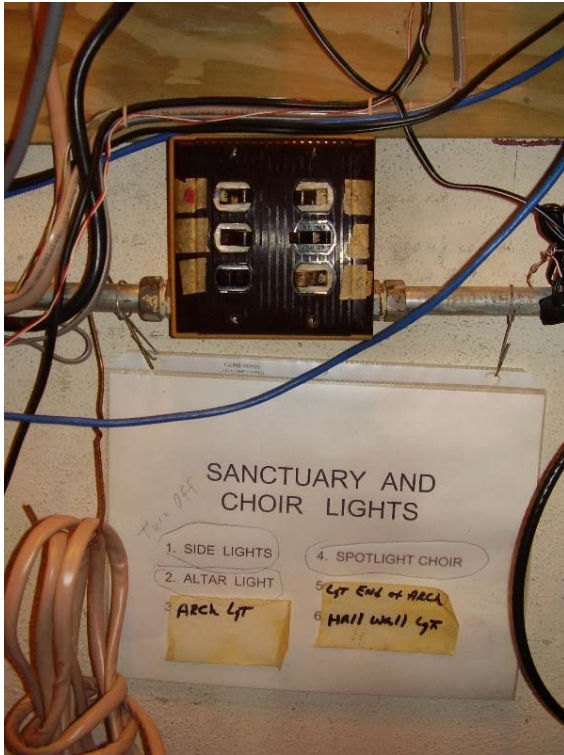
4. There is no logical or convenient method of controlling the lights in the sanctuary, choir, and altar areas. The sanctuary lights are switched from the organist area, but the choir area and altar area lights, along with some of the corridor lights must be switched from a set of switches in the corridor closet.

These switches for the choir and altar area lights are located in a closet in the corridor.

areas. Provide means for local control of all lighting, and eliminate the closet switches. Add accent lighting for the pulpit and other areas with separate controls to improve visibility and enhance the worship services.

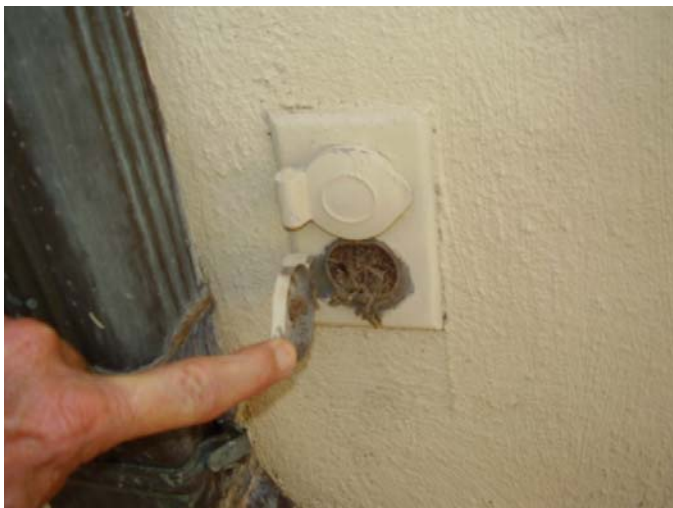
7. Outdoor receptacles were in poor condition and were not the ground fault type as required by the NEC. Ground fault receptacles are required by code in bathrooms, kitchens, wet locations, and outdoors to prevent electrical shock hazards and must be equipped with "weatherproof-in-use" covers when exposed to the weather.

Outdoor receptacles at the sanctuary are contaminated and in poor condition. These should be GFCI type to meet code.

8. Replace all of the outside receptacles with GFCI type with weatherproof-in-use covers.
9. Consider a lighting upgrade to improve general lighting levels, particularly in the sanctuary and choir

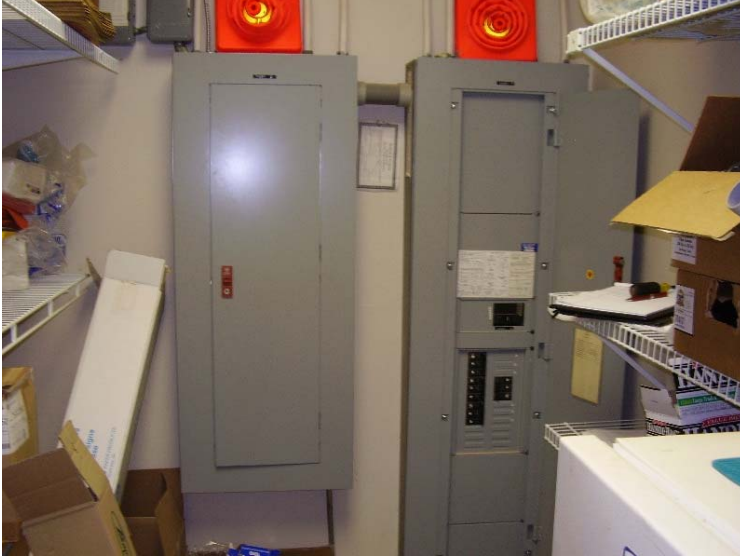
1. There is no main circuit breaker. In order to disconnect power to the building, all five breakers must be switched off. The NEC does allow up to six individual grouped disconnects, but this is not considered a desirable design. The breakers are not marked "Service Disconnect" as required by code, which could be a source of confusion for a fire fighter or someone servicing the building.
2. The high leg 120/240V delta service is an obsolete service voltage. See the comments above regarding the sanctuary service. Use of this system restricts the lighting and receptacles panels to single phase, and could be a hazard to someone servicing the system who may be unaware of the system voltage, since the voltage to ground on the "high leg" is approximately 200 volts instead of 120 volts as for

3. There is not adequate working space in front of the panel due to storage of items and the wall mounted shelving. The door of the main panel barely clears the shelving, while the code requires at least three feet clear working space. Storage of combustible materials, such as paper products, near the electrical panels also presents a fire hazard.

Bishop's Hall main panel "A" (right) and lighting and receptacle panel "B" (left). Note lack of clear working space and storage of combustible materials near the panels. Also, main panel "A" does not have a main circuit breaker, and the five breakers present are not labeled "Service Disconnect".

3. Remove the wall shelves in front of the main panel, and restrict storage of materials in front of these panels. Three ft. clearance is required for safety and to meet code.

6. Add "Service Disconnect" labels to the five breakers in main Panel "A". Add signage showing the service voltage and high leg service.
7. In the event of a major project on site, such as a building addition, consider reworking the service to standard 208Y120 volts. See similar comment under the sanctuary recommendations.

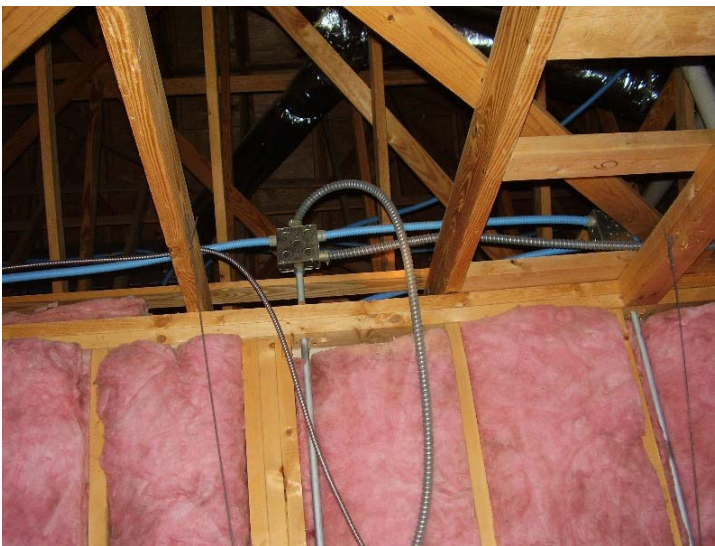
3. In general, workmanship of the electrical installation above the ceiling appears substandard, with unsupported junction boxes, unsupported conduits, and excessive use of flex. Conduit observed.

Above ceiling photo in Bishop's Hall showing improperly supported boxes and conduits and excessive use of flexible conduit. The blue conduit is the non-metallic tubing (ENT) referenced in the report. It appears to have been just laid through the attic framing, and not fastened down as required by the NEC.

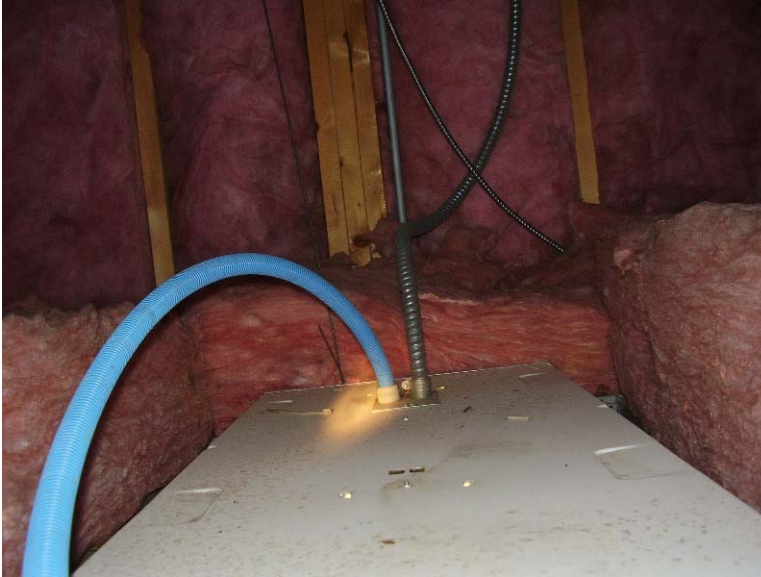
This photo is the top of a lay-in light fixture in Bishop's Hall showing the lack of hanger wires on the lights, as well as improper use and support of ENT conduit. By code, the ENT can run unsupported for a maximum of 6 ft at light fixture connections. Here it is being used in "daisy chain" fashion to wire from fixture to fixture.

4. Add emergency lights in the toilets.
5. Consider adding support wires to the lay-in fixtures. Because of the insulation batts on the ceiling, this work could best be accomplished as part of other work involving the ceiling.
